Controlled Demolition

of the Pietrastretta Bridge in Italy

by Roberto Folchi and Gianluca Auletta

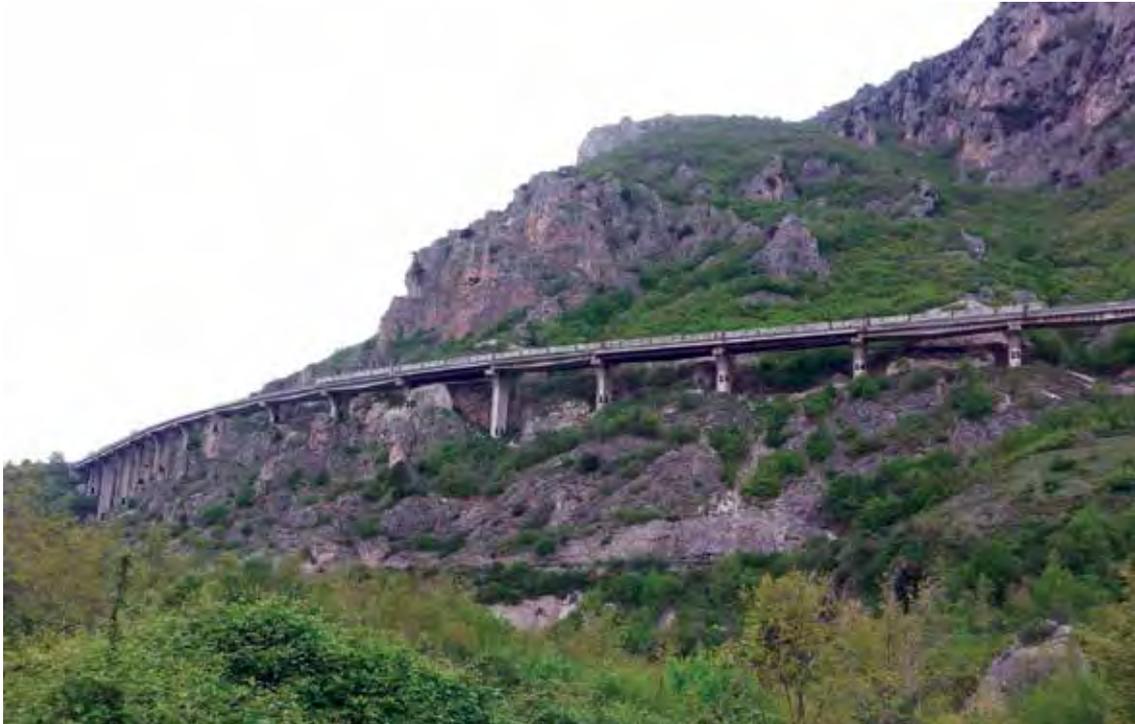
Figure 1. Profile of Pietrastretta bridge, spans from 1st to 16th (on a total of 21).

The Pietrastretta viaduct is part of the motorway junction Sicignano-Potenza, in the municipality of Vietri di Potenza. It is a 1 km (0.62 mile) long bridge, with a bend layout, halfway on a steep slope, with 21-spans (**see figures 1 - 4**).

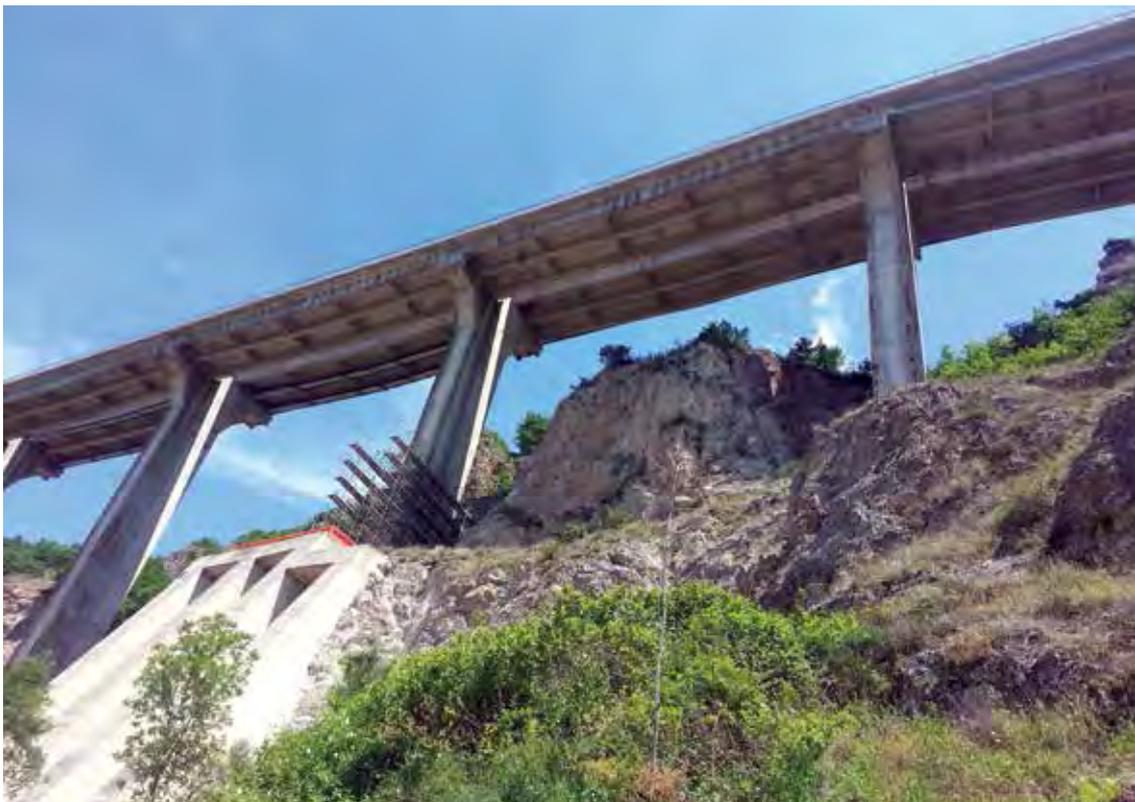
Figure 2. Detail of the bridge.

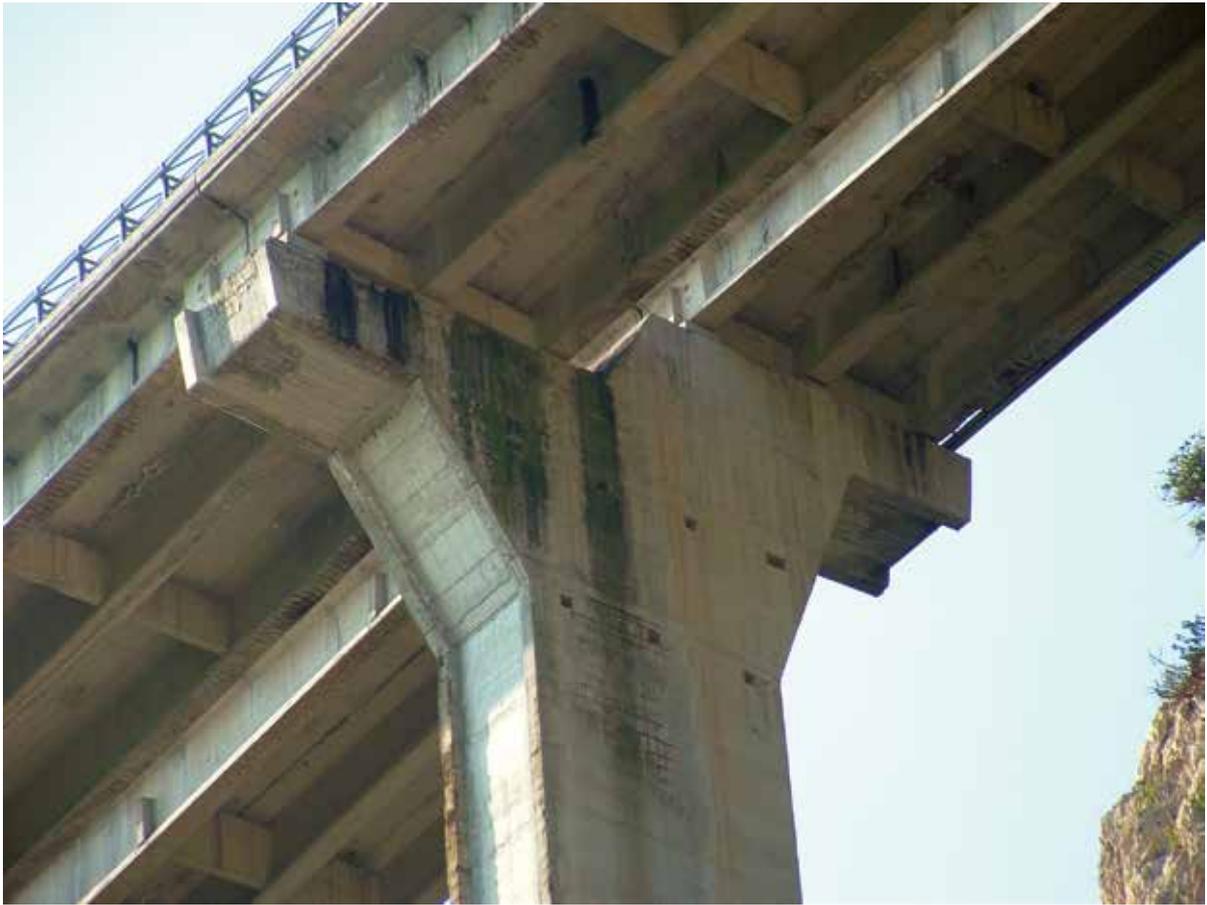
Figure 3. Detail of the cantilevers supporting the two carriageways and of the post-tensioned transverse beams tying together the three main beams.

The bridge has two independent carriageways, 3 meters staggered to match the slope profile. Both carriageways are supported on a transverse box-cantilevers from a single slim box-pylon. Height of pylons ranges from 12 to 50 meters (40 to 160 ft). Spans are built with 3 "I" beams of pre-stressed concrete with a height of 1.75 m (70 in) at the support and 2.7 m (106 in) in the middle. Six post-tensioned transverse beams and a slab 9.5 meters (31 ft) wide and 20 cm high (8 in) bind together the three main beams.

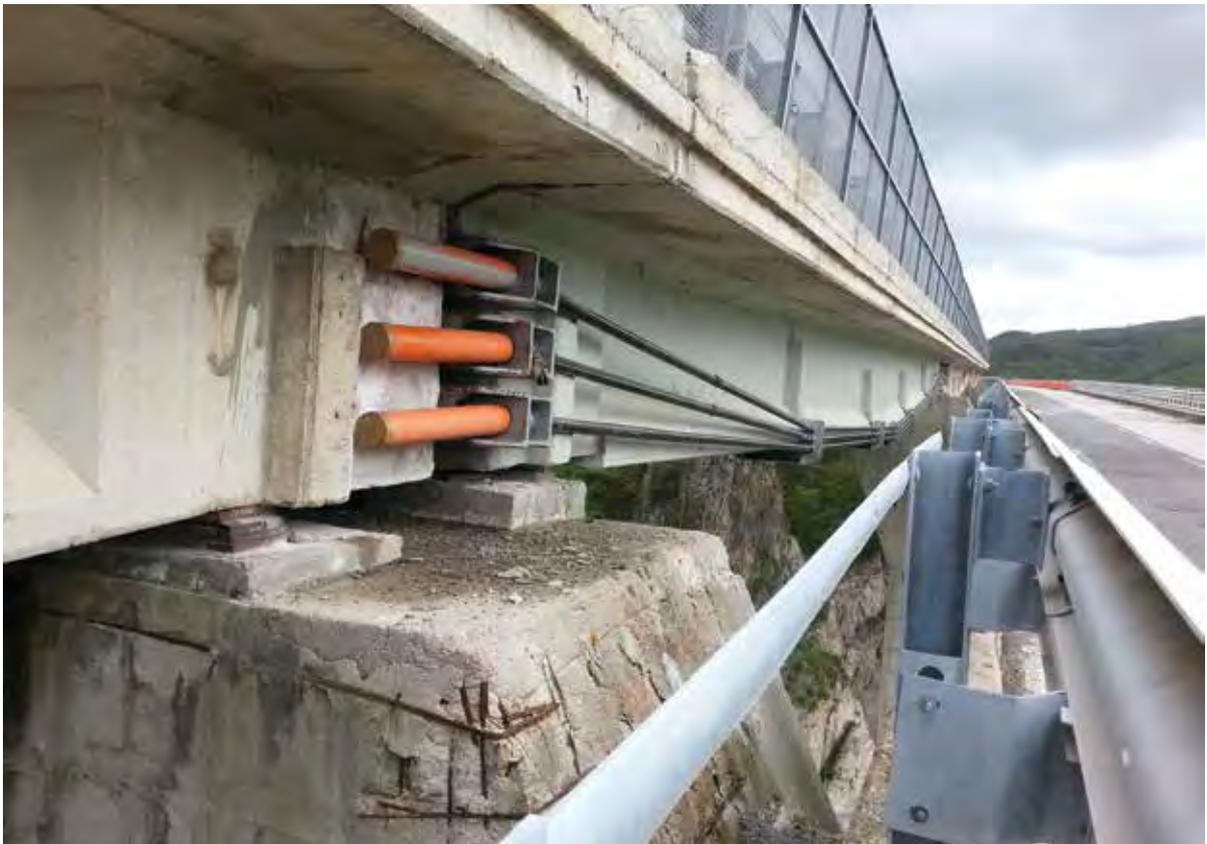
Figure 4. Northern (left, to be left in place in service) and Southern carriageways of the Pietrastretta bridge.

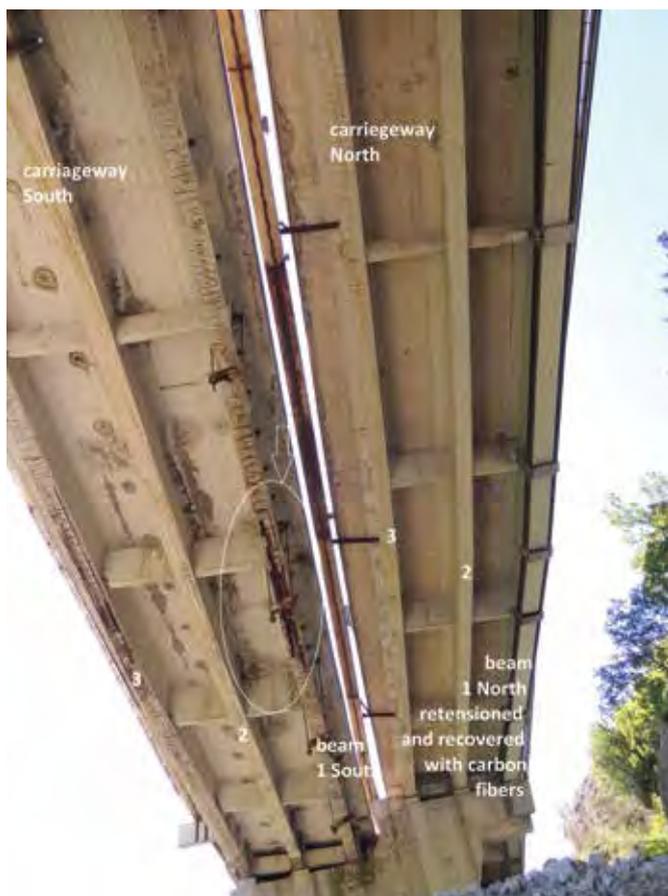
Figure 7. Strong degradation of the beams at 12th span southern carriageway, lower flange, with lost of concrete layers, extended corrosion and broken re-bars and tensioning wires.

In a preliminary survey it was confirmed that all beams were inflicted by widespread degradation with loss of concrete volumes, exposition of reinforcement bars, and tensioning wires with consequent corrosion (see figures 7 and 8). Local reinforcement appeared to be deeply rusted and also cracked. This degradation showed a lower grade in the middle beam in comparison with the external ones. A higher degradation was noticed in the lower flange in comparison with the upper one. Similar deep degradation also involved the slab but

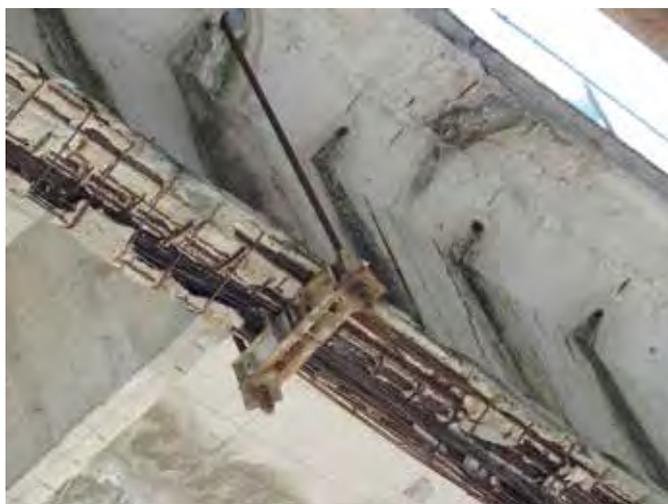
Figure 8. Detail of degradation.

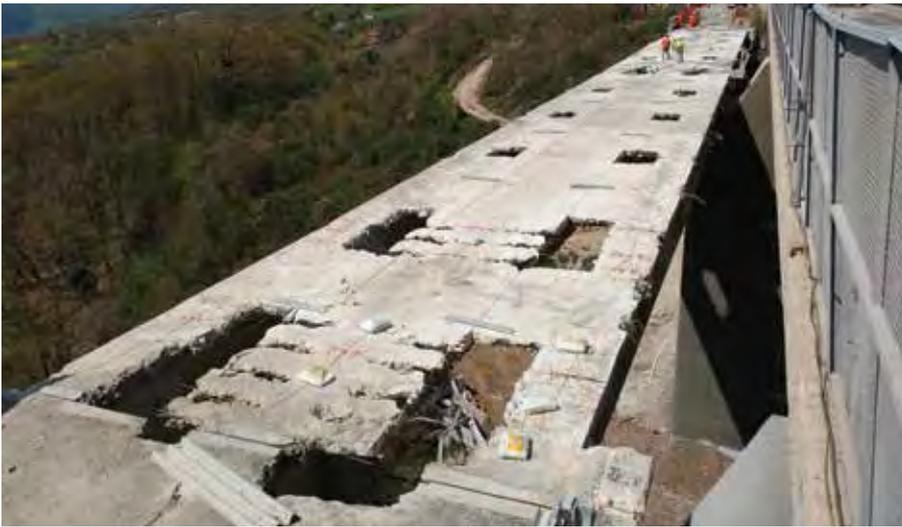
Figure 18. Span prepared and loaded for triple-step blasting.

Two demolition scenarios were analyzed, both including drilling of holes for explosive and cutting of the slab and beam upper flange for weakening, one of the two including a span divided in three longitudinal sections to be removed by blasting one by one (triple-step blasting) instead of the whole span at a time (single-step blasting).

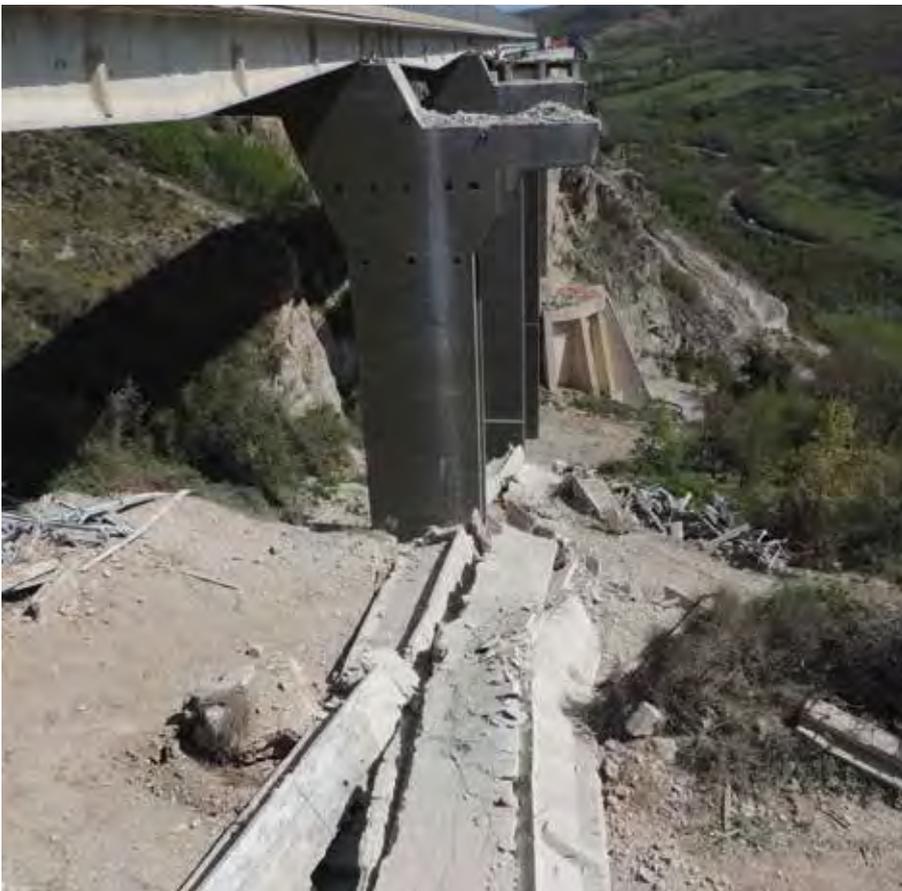
Figure 19. Span blasted in triple-step at the ground.

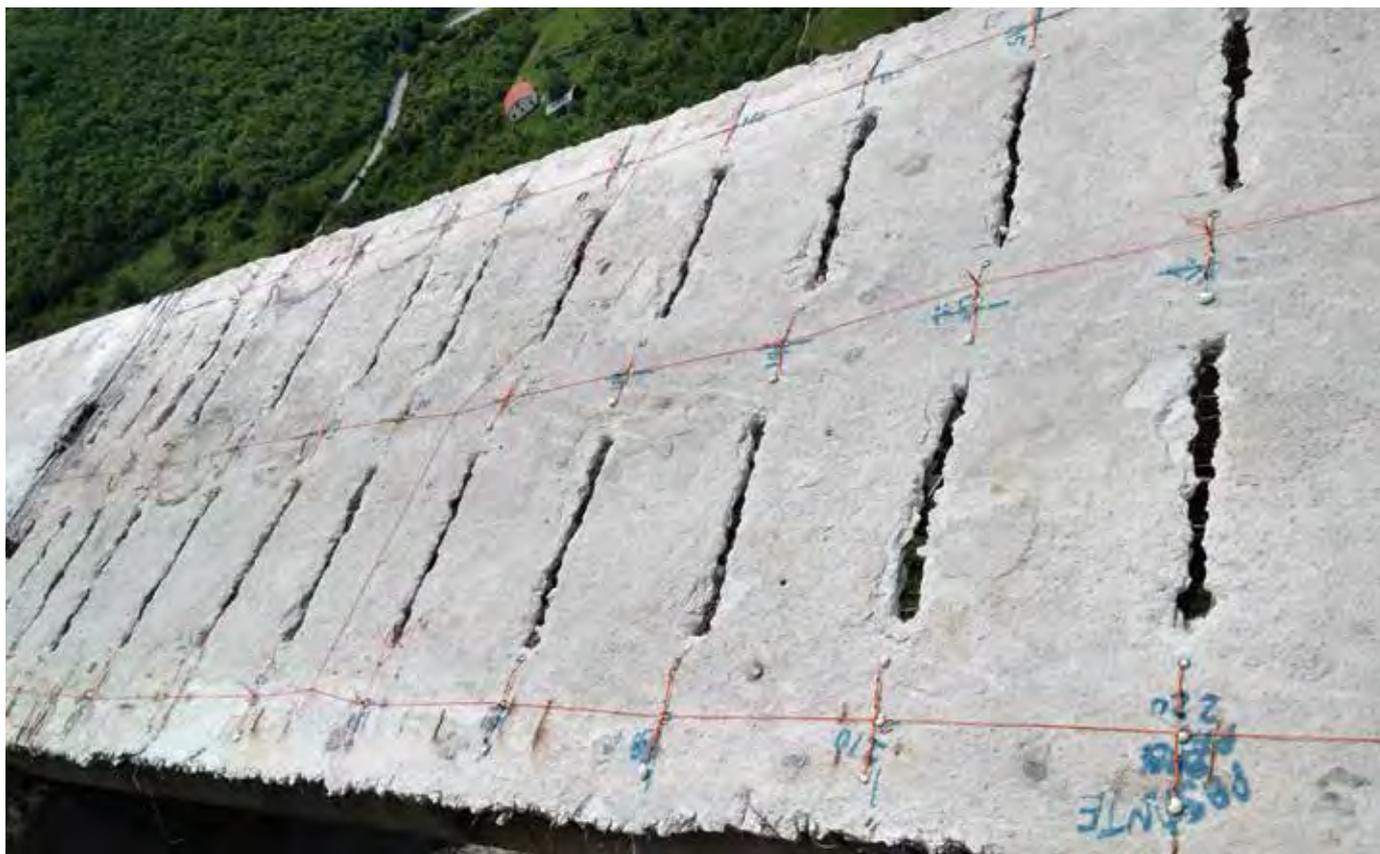
Figure 20. Span prepared and loaded for triple-step blasting.

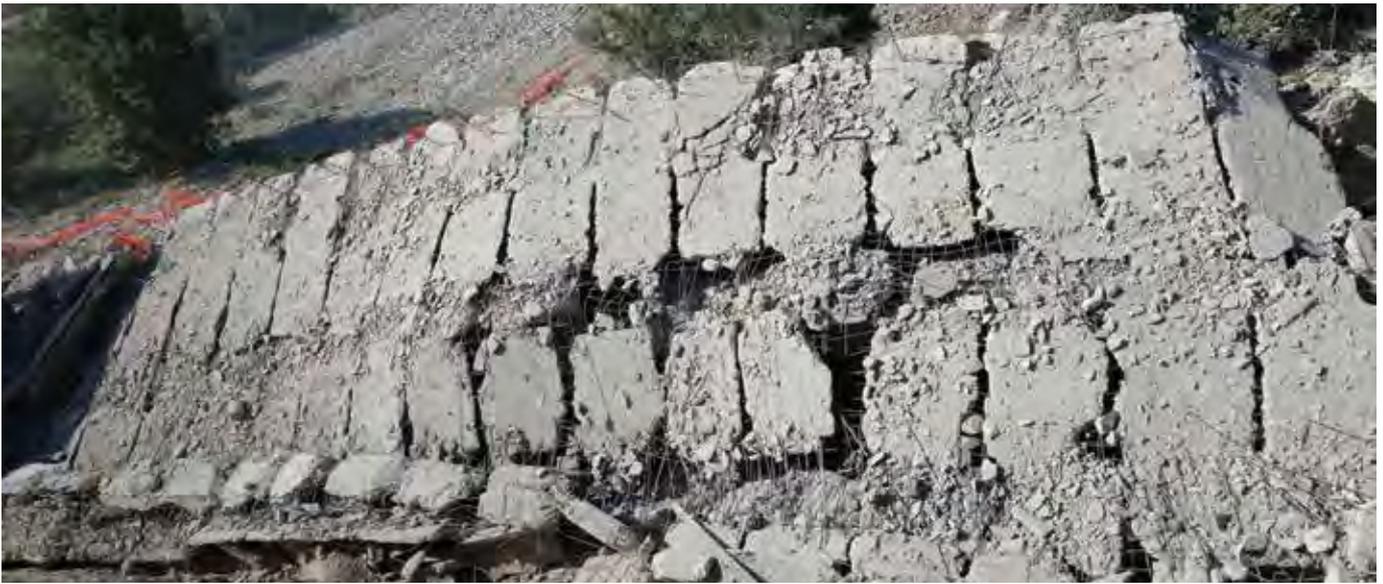
Figure 21. Span blasted in one single-step at the ground.

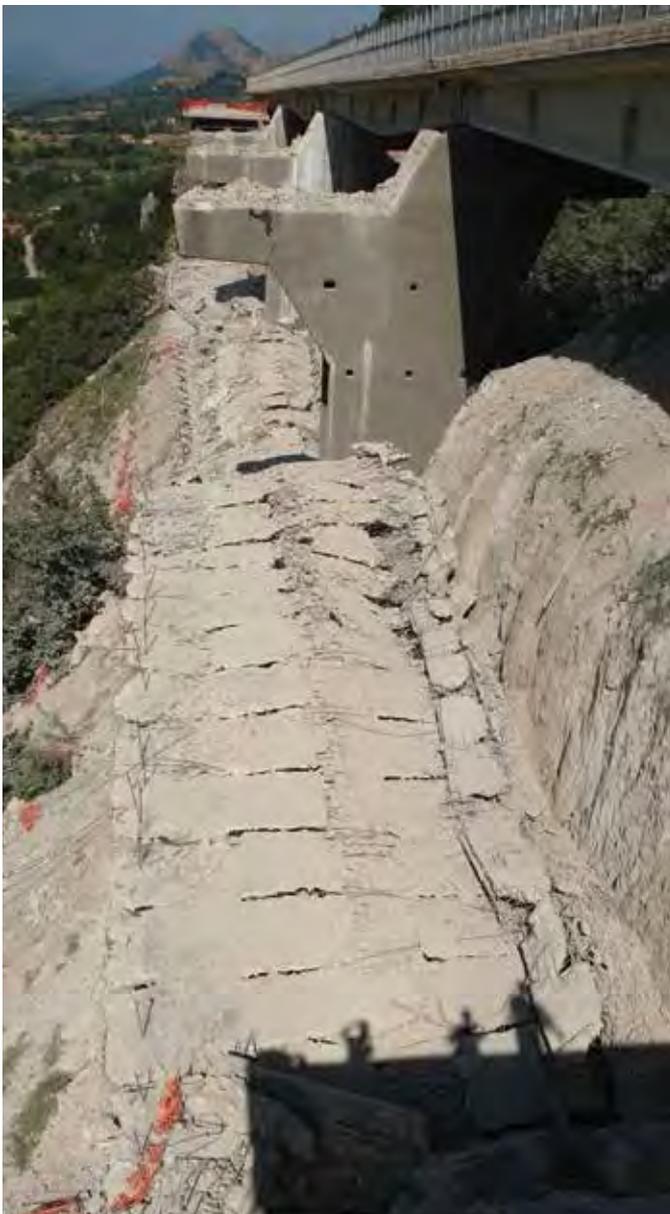
Figure 22. Several spans blasted in one single-step at the ground.

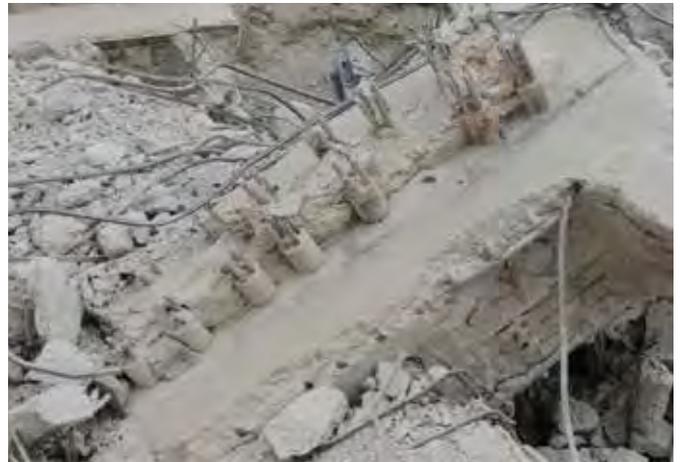
Figure 23. Detail of the tensioning heads being exposed after the blast.

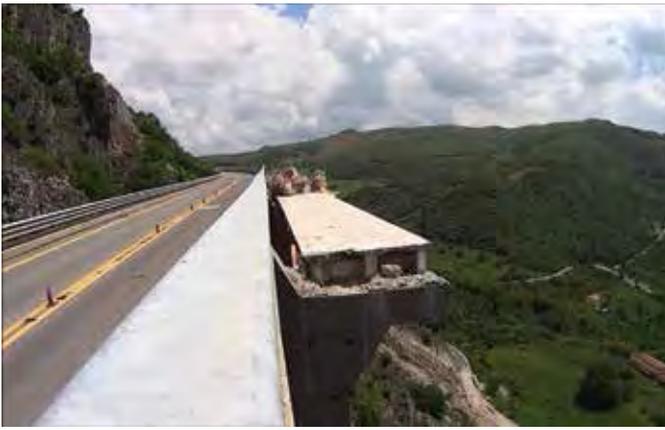
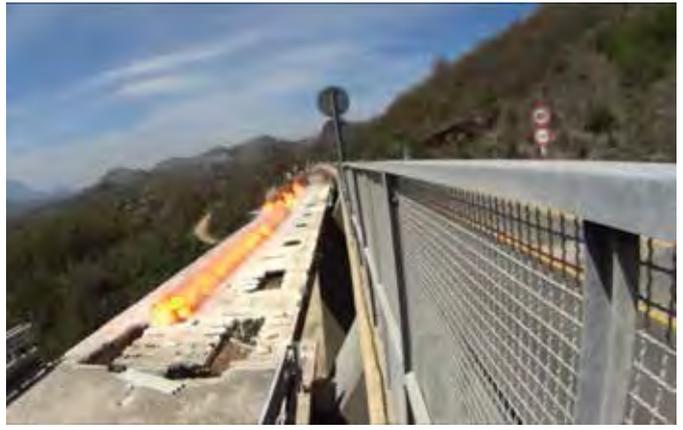
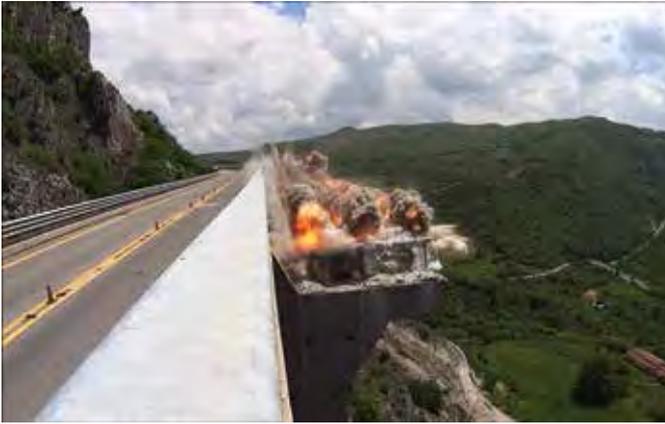
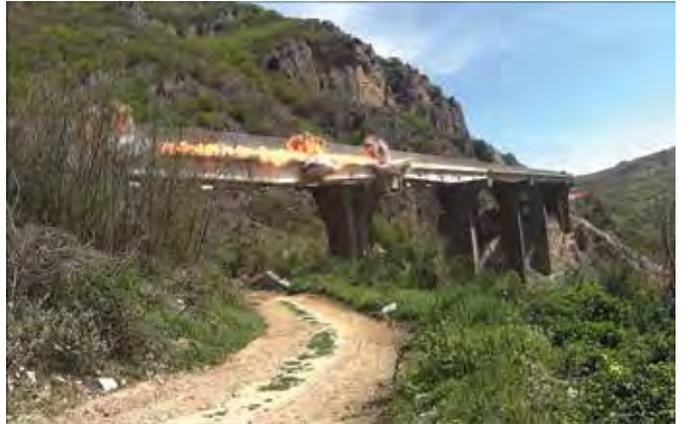
Figure 24. Sequence of blasts.
