DEMOLITION OF BRIDGES WITH EXPLOSIVES

Experience in the last decade in Italy with reinforced concrete bridges

By Roberto Folchi and Gianluca Auletta

Volume 35 Number 2
March/April 2018

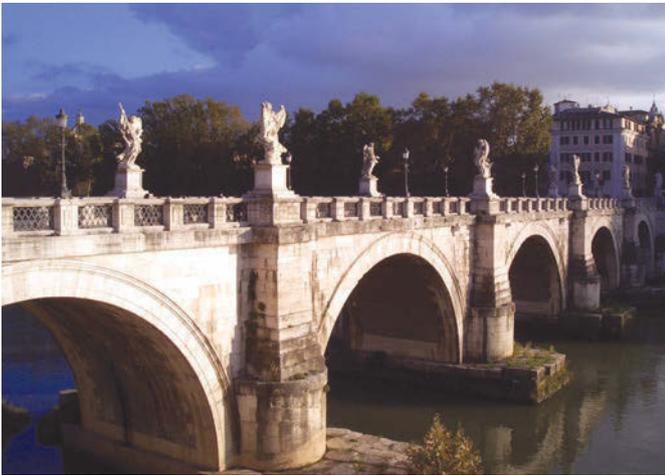
Figure 1. Ancient Roman round arch bridge "S. Angelo" in Rome, built A.D. 134 (photo by Wampile).

There are hundreds of (ancient) bridges built two thousand years ago that are still in service, with their dead load up to five times that of modern bridges, carrying live loads (cars and trucks) up to 10 times that was foreseen at the time they were built (horses and carriages). Apart from cosmetic deficiencies due to weathering, tenths of earthquakes and plundering, they still maintain a high structural safety margin toward the ultimate resistance.

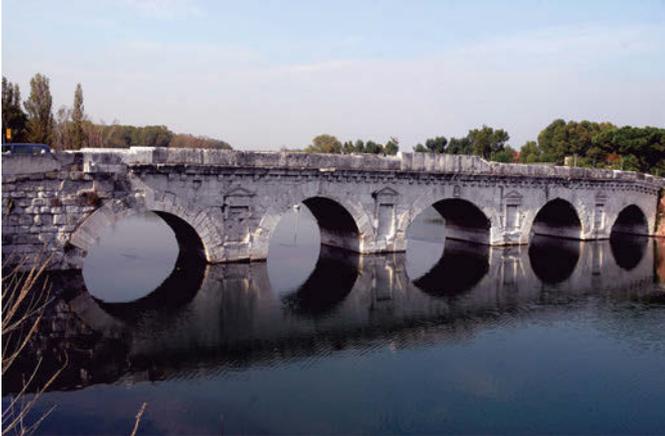
Figure 2. Bridge "Tiberius" in Rimini, Italy, built A.D. 21 (photo by Heiko Trumit).

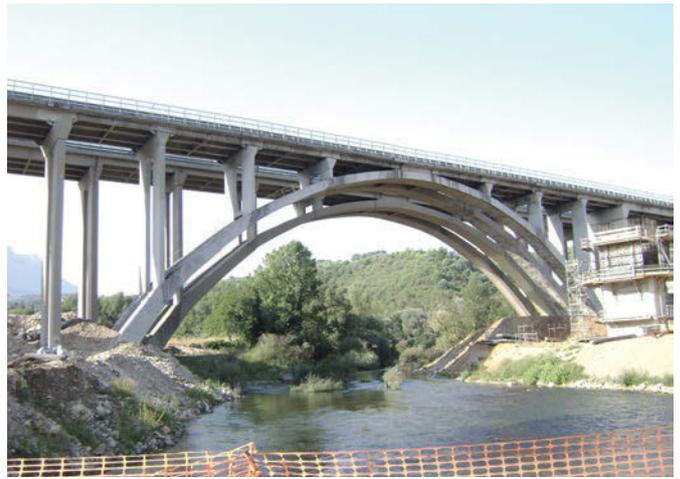
Figure 3. Bridge "Tanagro," Italy, built 1970. Reinforced concrete arch surmounted by twin full concrete pylons carrying single 32 m simply supported spans four I girders carriageway.

This is not the case with old bridges of modern conception, built in the second half of the 20th century in pre-stressed concrete (see figures 3-7). Those suffered an aging speed of 30 to 50 times faster than their predecessors of ancient Roman age. Several of them are running ahead of their life-cycle in just 40 years, some others are already ahead of it, especially if referring to the latest safety standards for ultimate resistance and seismic loads.

Affected bridges were built with reinforced concrete, with pylons of a maximum height reaching 130 m (430 ft). The horizontal span length varied, generally 16, 32 or 45 m (about 50, 100 and 150 ft), on generally four post-tensioned I girders, sometimes only three. Some of the pylons had longitudinal cantilevers, for spacings up to 80 meters (some 260 feet). Some other pylons had transverse cantilever to sustain both carriageways; others were built above arches for a spacing up to 145 m (480 ft). Examples of those kind of bridges is given in **figures 3-7** (see also reference 1).

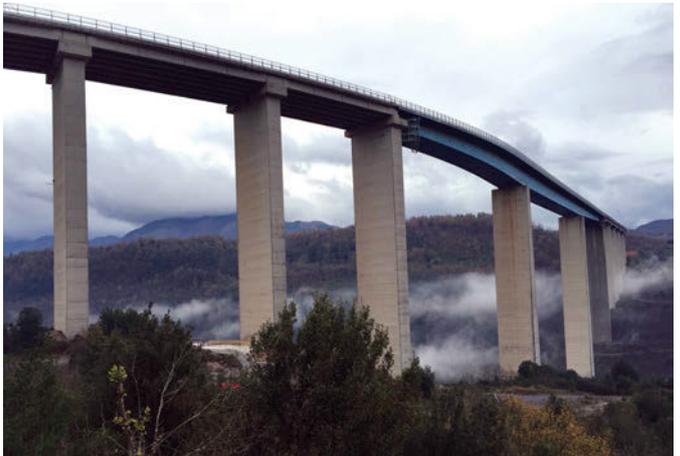
Figure 4. Bridge "Italia," Italy, 1968. Single box pylons with internal wall, carrying double 45 m simply supported spans four I girders carriageway.

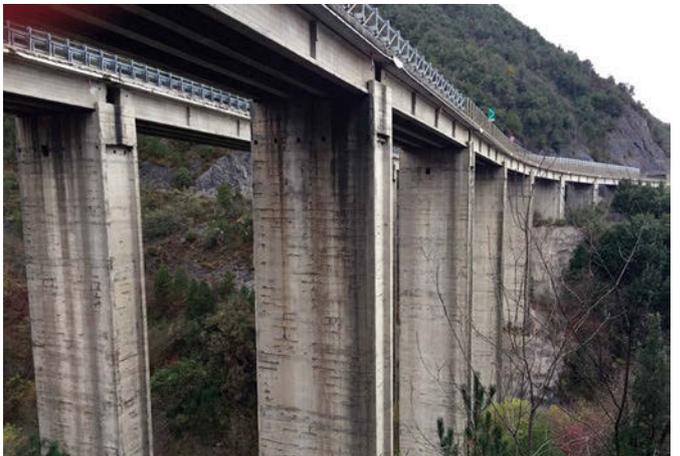
Figure 5. Bridge "Battendiero 1," Italy, 1970. Single box pylons for single 32 m simply supported spans four I girders carriageway.

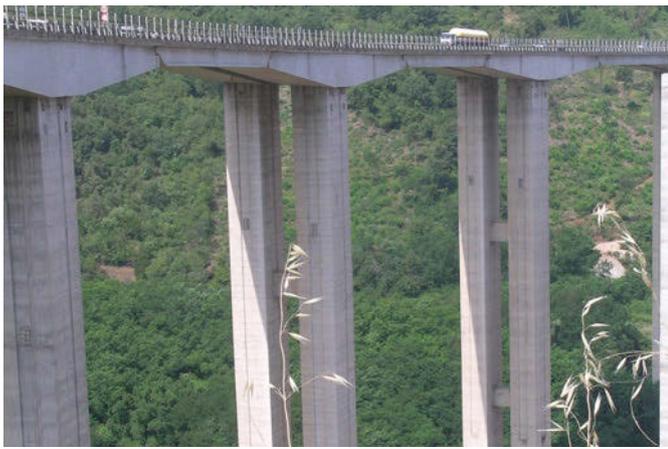
Figure 6. Bridge "Lontrano," Italy, 1968. Single thick walls box pylons with quadruple 25 m long cantilevers carrying double 32 m spans carriageways.

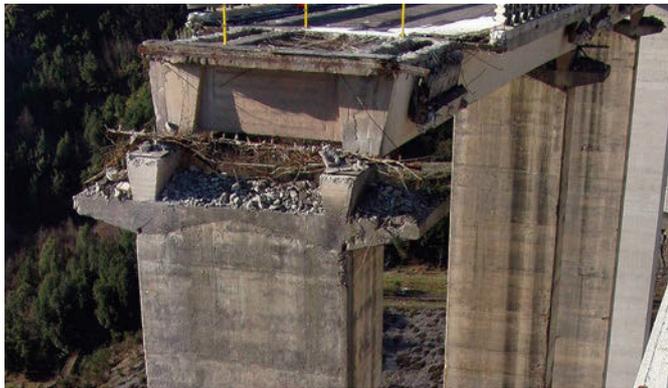
Figure 7. Bridge "Noce" Italy, 1970. Single thick walls box pylons carrying single 32 m spans carriageway double box girder.

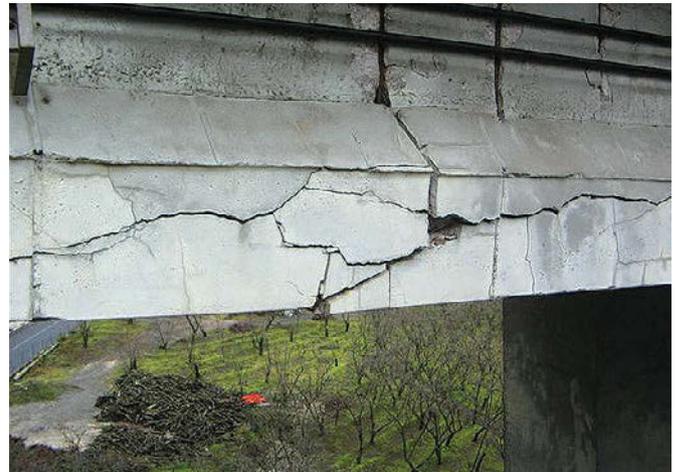
Figure 8. Large cracks in the lower bulb of a reinforced concrete pre-tensioned I girder.

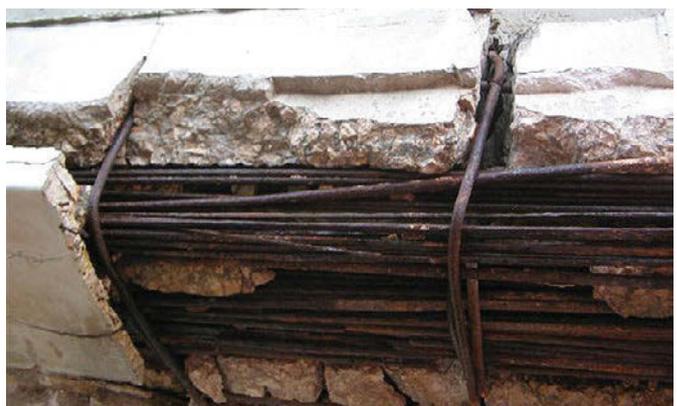
Figure 9. Re-bars and tensioning bars exposed and corroded after concrete cover collapse in the lower bulb of an I girder. Due to excessive re-bars, concentration concrete could not properly wrap around.

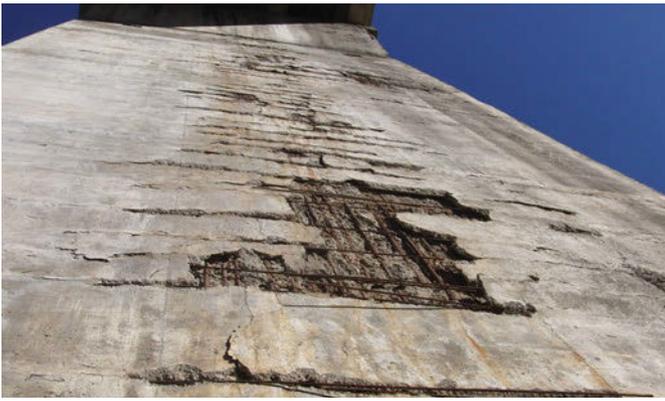
Figure 10. Reinforcement bars exposed and corroded in a box type concrete pylon.

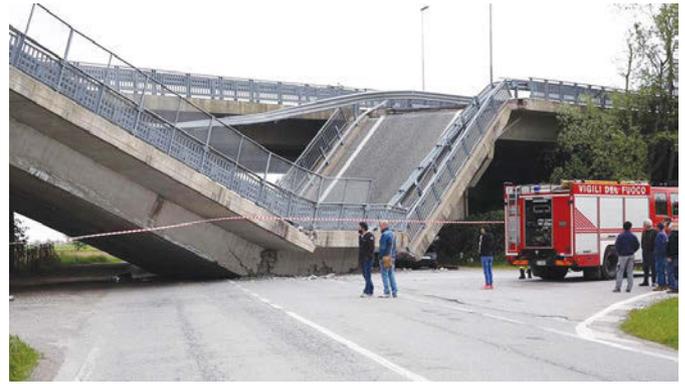
Figure 13. Collapse of a highway overpass causing no casualties, 2017.

Bridges ahead of their life-cycle may suffer major damages. In worst case scenarios, it would collapse while in service with the possibility of lost lives and impact on social life and economy (figures 12 and 13).

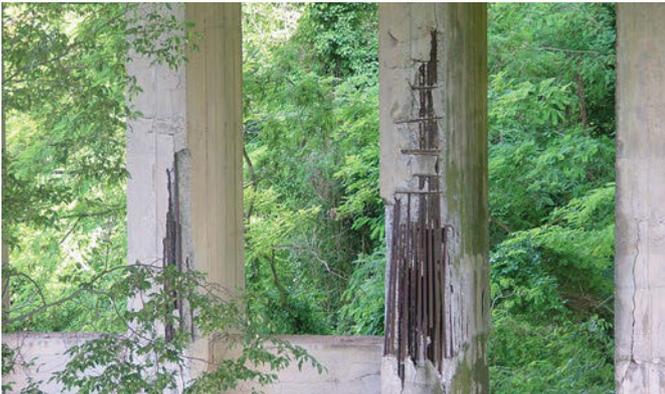
Figure 11. Reinforcement bars exposed and corroded in a grid full concrete quadruple rectangular piers pylon.

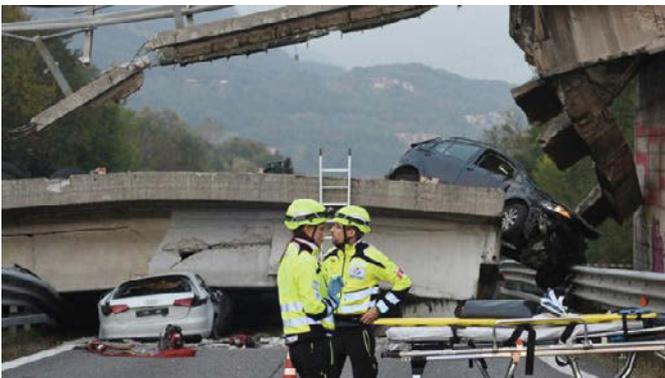
Figure 12. Collapse of a highway overpass causing casualties, 2016.

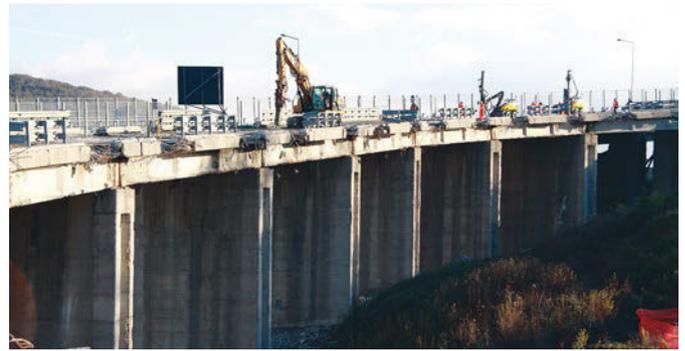
Figure 16. Preparing the spans to be blasted, by breaker on remote controlled excavator for preliminary decks demolitions and by remote controlled wagon drill for boreholes in the girders

Explosives were used to create plastic hinges triggering collapse in a given sequence and direction of the sole spans (reference 2) or of the whole bridge (**figures 16-27**). Concrete fragmentation was achieved by detonating small diameter explosive charges (generally 35 to 190 grams dynamite but sometime up to 500 grams).

Preliminary cuts of the reinforced concrete were executed with diamond tools or small breakers on remote controlled excavators. Reinforcements and tensioning bars were left in place.

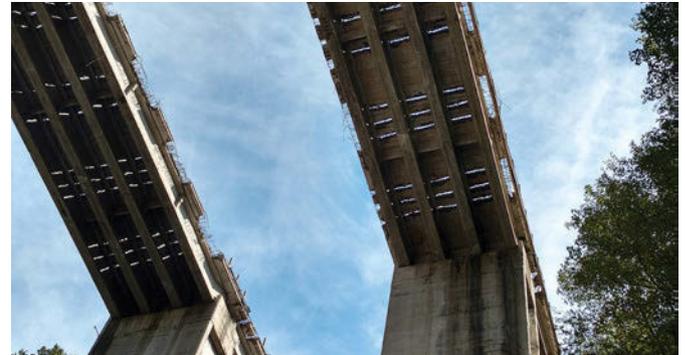
Figure 17. Spans ready to be blasted for extended explosives demolition due to constraints at footprint (steep slopes and structures to be safeguarded). I girder type (as bridges in figures 3-6).

In case of steep slopes at the footprint, where falling spans or pylons could slide toward the closest acceptor such as the pylon ahead to be left in place, or just slide away down making it impossible to retrieve for removal and crushing [reference 2], explosives were spread out in the structure for extended fragmentation. In some cases disintegration was needed to keep structures safe that were standing right below the span to be demolished (as the case of the pylon in **figure 23**).

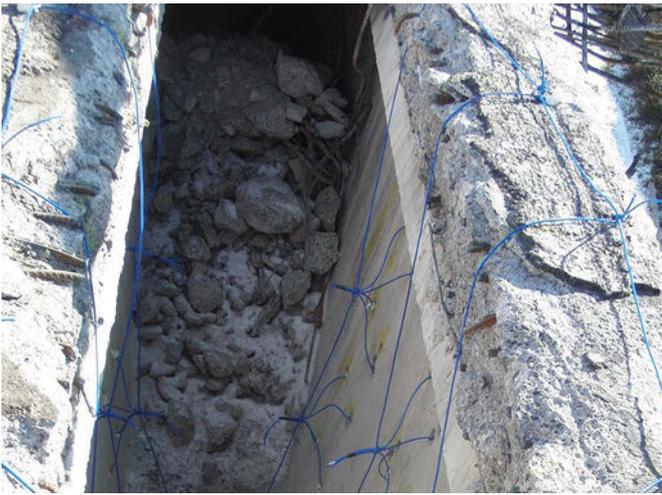
Figure 18. Spans ready to be blasted - box girder type (as bridge in figure 7).

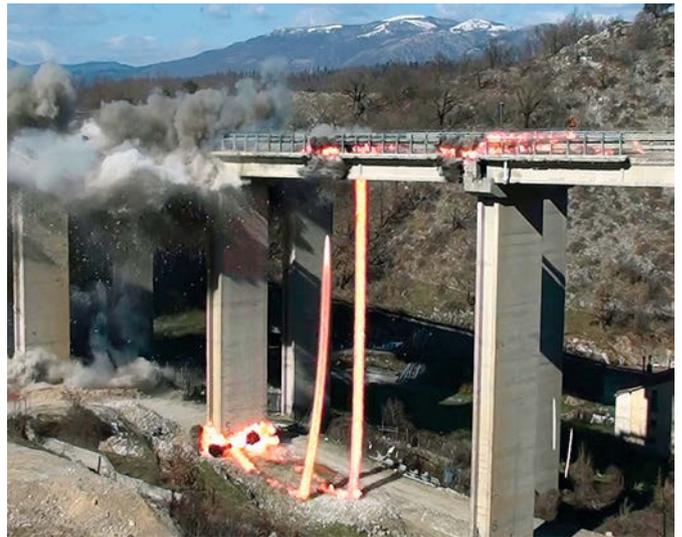
Figure 21. Spans and pylons blasted in sequence (redundant detonating cord circuit and firing sequence by redundant non electric detonators).

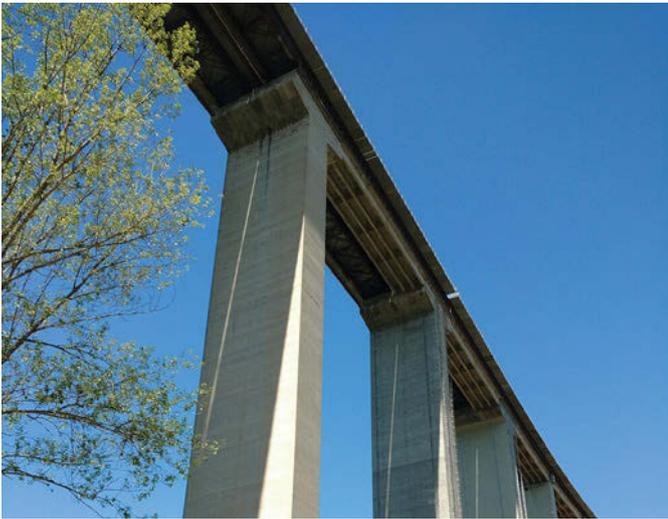
Figure 19. Spans to be demolished by safeguarding own pylons or with the new superstructure already in place built right above (before the blast).

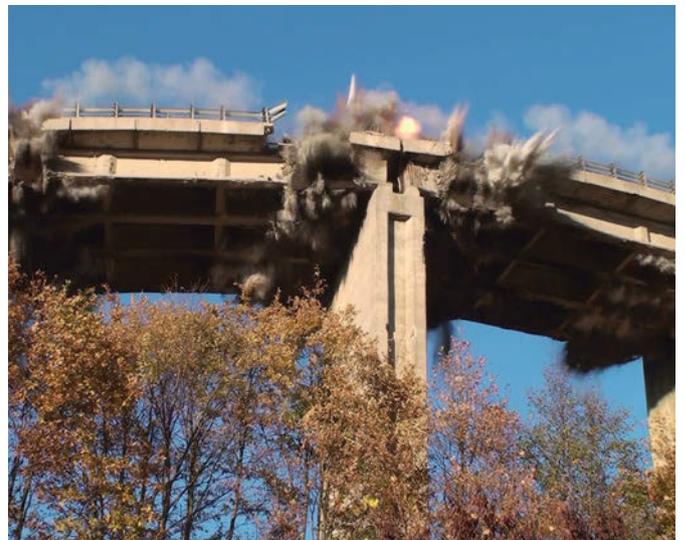
Figure 22. Spans and pylons blasted in sequence, safeguarding own pylons.

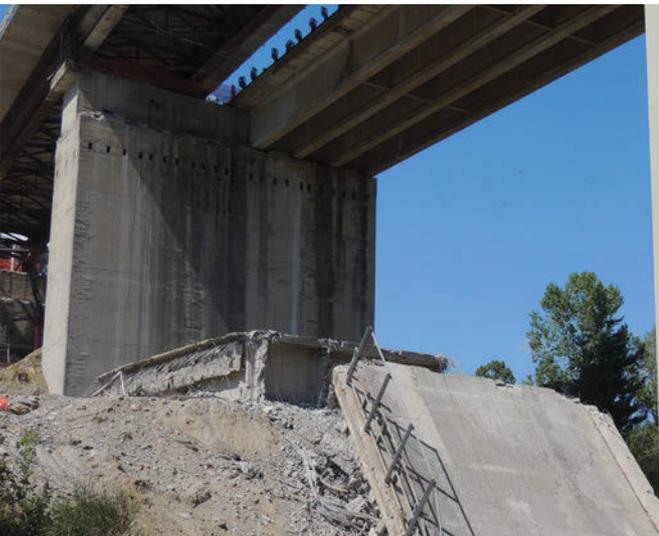
Figure 20. After the blast.

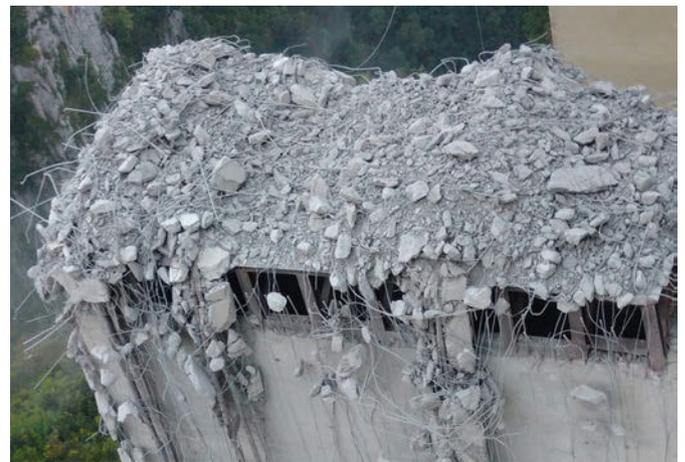
Figure 23. Concrete debris, re-bars and tensioning steel left from the extended explosives demolition of a 650 ton span overlaying this new pylon standing 17 meters right below it (see figure 17).

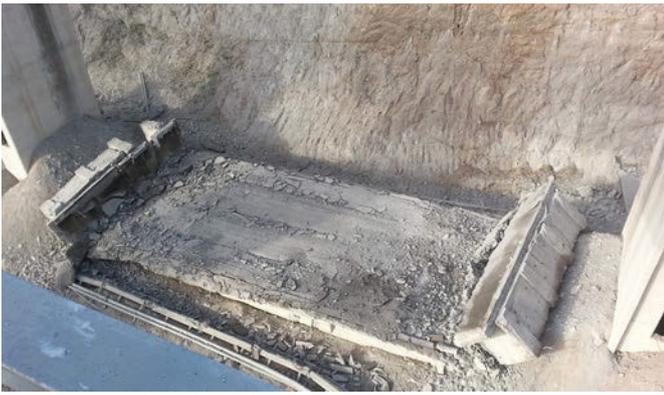
Figure 24. Heads of the girders from both sides of the spans are seen rotated and laying above the deck.

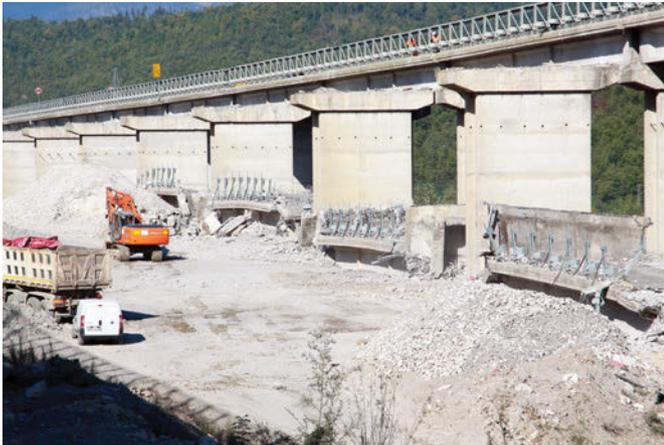
Figure 25. Span at the ground among own pylons. Collapse determined by hinging the beams close to their bearing spots.

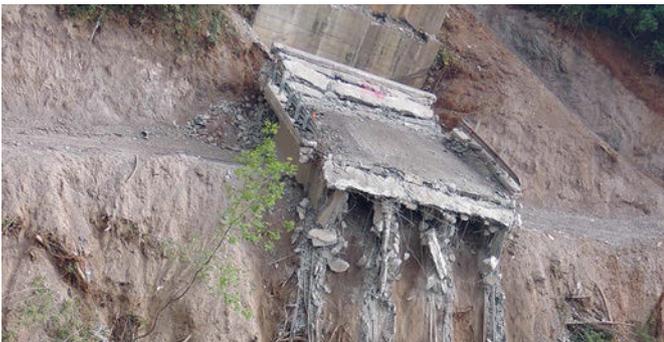
Figure 26. Spans more extensively demolished for better adjustment on the steel sloped footprint, to prevent its sliding toward the pylon below.

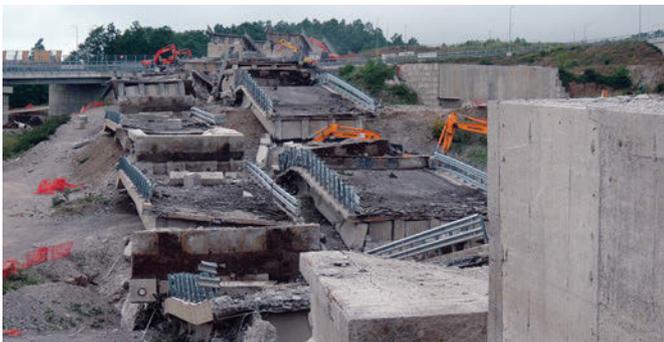
Figure 27. Spans and pylons at the ground, ready for mechanical breaking.
